PLAINTIFF'S MOTION FOR JUDGMENT ON THE PLEADINGS

PROPERTY INSPECTION REPORT

Robert Hudnall	2/14/22
Name of Client	Date of Inspection
297 Puesta Del Sol, El Paso TX 79912 Address of Inspected Property	19 11 1 1 1 1 1 1 1 1 1 1 1 1 1 1 1 1 1
	7144
TIMOTHY ALAN SANK Name of Inspector	TREC License #

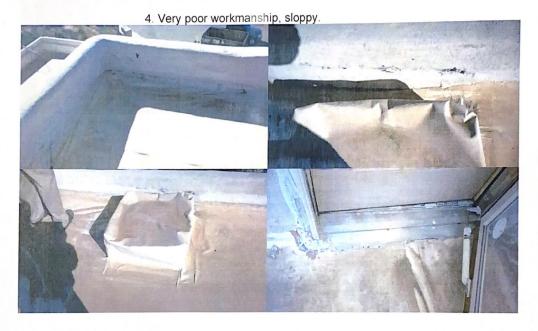
3. Vent pipes and Air vents were covered over, trapping moisture in the
